**Project Ophir**

**Summary Report for the  
Central Otago Heritage Site Review (COHSR)**

Prepared for Otago Goldfields Heritage Trust

Absolute Archaeology Ltd

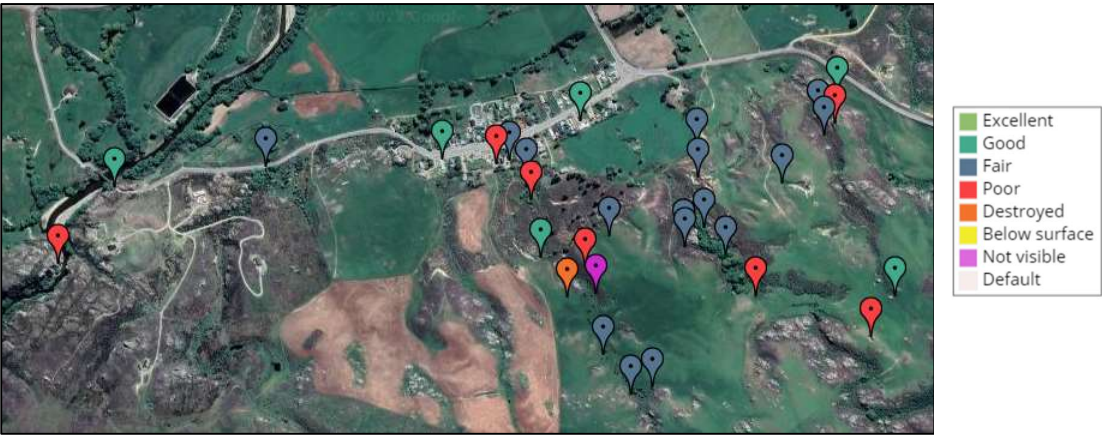
**Figure 17.** Rated condition of site fabric.

Over half of the 31 sites (16 sites 51.6%) were considered to be in fair condition and 6 sites (16.13%) were considered to be in good condition. A further 7 sites were recorded in poor condition (22.5%) and 1 site (3.2%) is no longer visible (Front Gully Reef G41/705, Waldron’s Gully). One site the Waldron hut site (G41/613) is sub-surface with no above ground fabric remaining.

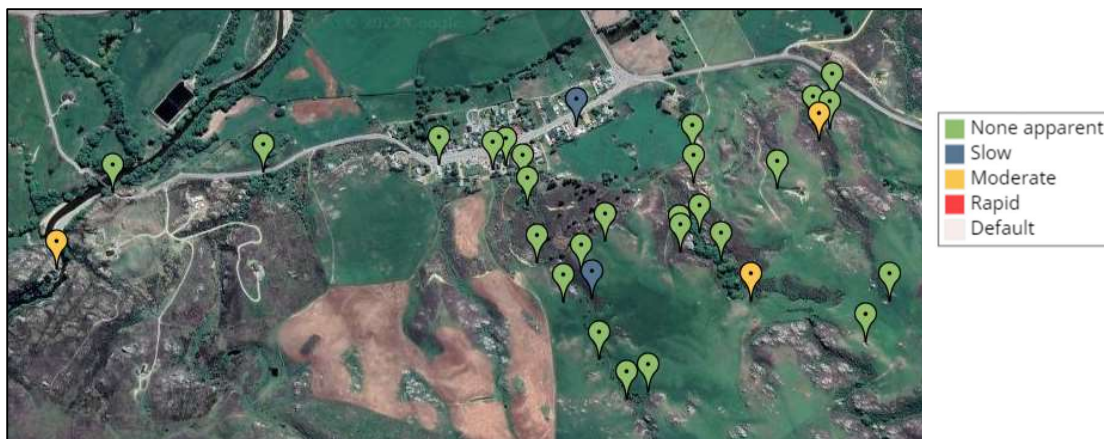
**Figure 19.** Rates of deterioration noted for sites.

Rate of deterioration	Count
Moderate	3
None apparent	2
Slow	26
Total number of sites	31

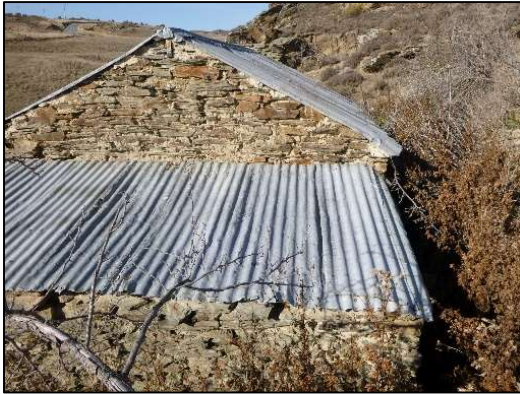
**Plate 1.** Mactavish's hut (G41/702, GPS 097), Blue Nose Gully. View south-east.

Mactavish's hut (G41/702, GPS 097, Plate 1) in Blue Nose Gully requires maintenance for improving drainage and moisture accumulating along the rear wall. The roof guttering has fallen from the roof along the rear wall. Recommended maintenance tasks include replacing window panes, have the chimney cleared, bird-proof walls and roofing, and replace the guttering. End wall stone work requires the addition of mortar to stabilise the stone. Vegetation is to be cleared and the sediment that has built up around the base of the rear wall is to be dug out to promote drainage. The sediment clearance should be monitored by an archaeologist and any artefacts uncovered are recorded. Ensure run off from the guttering leads away from the hut walls.

The rear wall of Mactavish's hut (G41/702, GPS 097, Plate 1, Figure 6) in Blue Nose Gully requires vegetation removal to improve drainage. The rear wall will need to be kept free of vegetation and soil build up to reduce moisture.

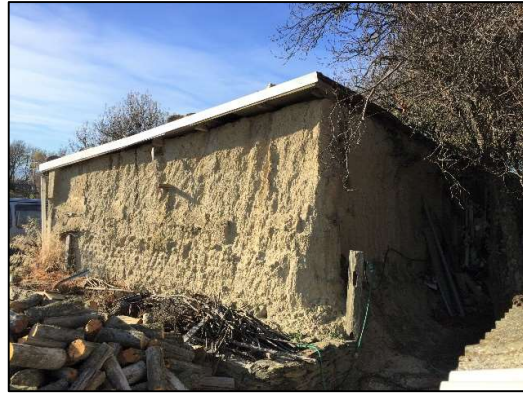
**Plate 2.** View north-east to west side wall (left) and south rear wall (to right) of Ryan's Bendigo Hotel Stables (G41/708, GPS 375: Sarah Gallagher).

Modification is recommended to the Ryan's Bendigo Hotel Stables roof (G41/708, GPS 375) by adding on corrugated iron sheeting to extend out past. This should provide shelter from rainfall to reduce impacts of the severe water damage to the rear wall.

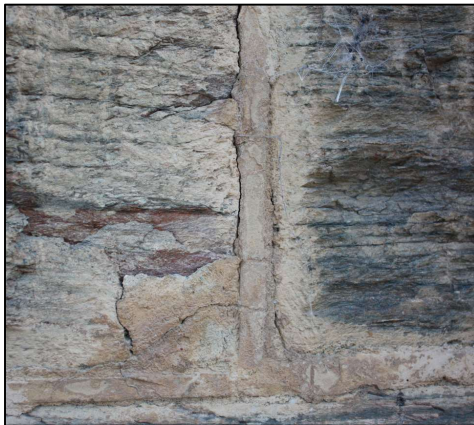
Some of the packing between the stone work of the Daniel O'Connell Bridge abutment (G41/694, GPS 408) is cracking (Plate 3, Figure 3: Appendix 2). A specialist stone mason is required to determine correct mortar mix to apply to the stonework and whether it is best practice to remove any existing concrete mortar. CODC are responsible for the maintenance of the Daniel O'Connell Bridge.

**Plate 3.** Cracked packing in the stone work of Daniel O'Connell Bridge abutment (G41/694, GPS 408).

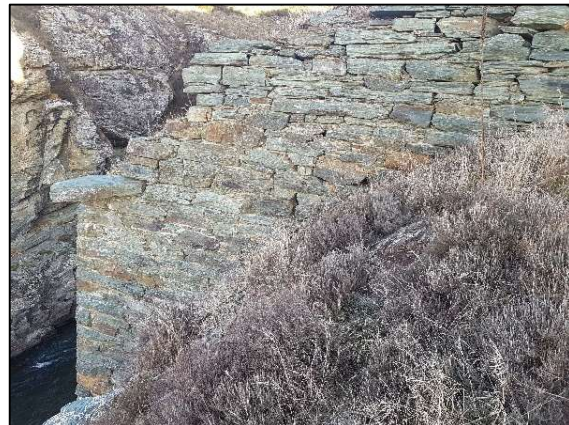
**Plate 4.** Early footbridge abutment (G41/601, GPS 033), true right bank Manuherikia River, Blacks/Ophir (T Davis). View south.

Blocks of green schist are slowly eroding from the abutment of the early footbridge (G41/601, GPS 033, Plate 4, Figure 3: Appendix 2) spanning the Manuherikia River south of the Daniel O'Connell Bridge. It is recommended an experienced stonemason assess and reports on the condition and stability of the stone stacking of the schist culvert (G41/595) west of Ophir Township beneath Ophir Bridge Road (GPS 376). It is not known if the land manager has this culvert on their maintenance schedule and an engineer is already responsible for the stability of the culvert.

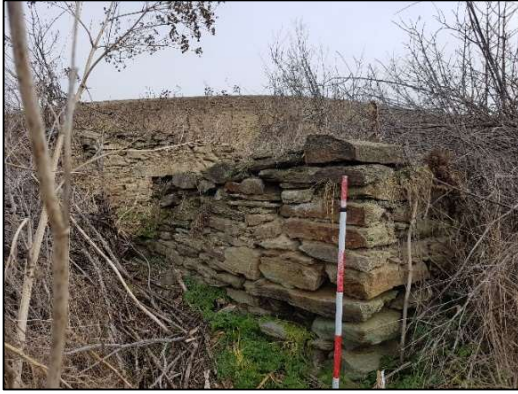
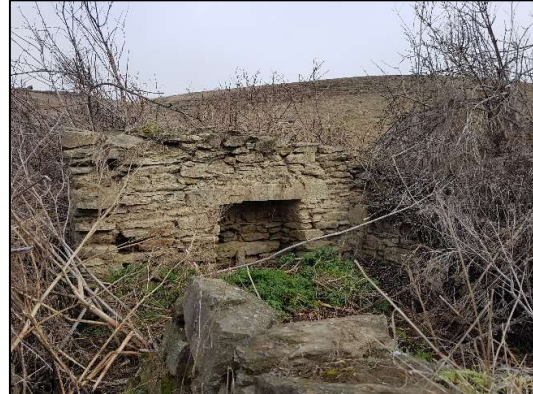
Stabilisation of the hut walls and chimney of Pitches Dam Raceman's hut (G41/711, GPS 113, Plates 5-6, Figures 5-6: Appendix 2) in McLeod's Gully is required by an experienced stonemason. Mortar capping along the tops of the walls is recommended as is annual monitoring after stabilisation and capping.

**Plate 5.** Pitches Dam Raceman's hut (G41/711, GPS 113) McLeod's Gully. View south-west.

**Plate 6.** Pitches Dam Raceman's hut (G41/711, GPS 113) McLeod's Gully. View south-west.

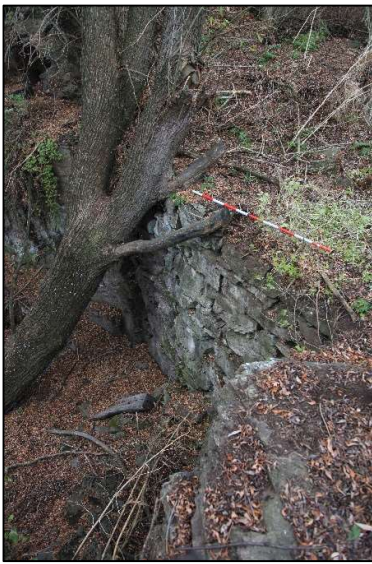
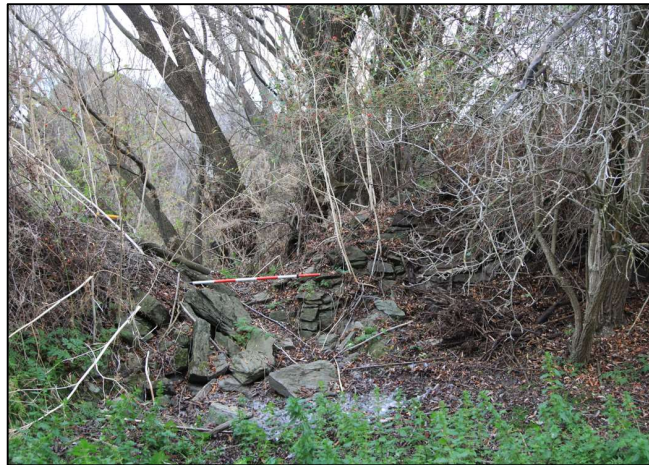
**Plate 7.** Pitches Dam wall (G41/700, GPS 111-112), McLeod's Gully. View east (M Sole).

**Plate 8.** Collapsed centre of Pitches Dam wall (G41/700, GPS 111-112), McLeod's Gully. View north-west (M Sole).

Mortar to be adhered to the stacked stone wall of Pitches Dam to stabilise the stonework immediately following tree removal from the dam wall (Plates 7-8, GPS 111-112, Figures 5-6: Appendix 2).

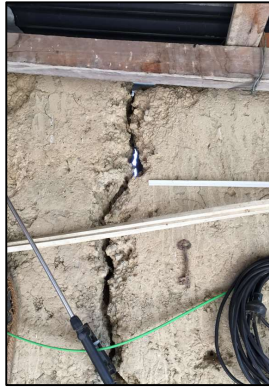
The south-west wall of Ryan's Bendigo Hotel Stables (G41/708, GPS 375, Plate 9, Figure 4: Appendix 2), 39 Swindon St, has a severe longitudinal crack requiring a specialist assessment to determine the best course of action to stabilise the rammed earth wall.

**Plate 9.** View west to cracked side wall inside Ryan's Bendigo Hotel Stables (G41/708, GPS 375).

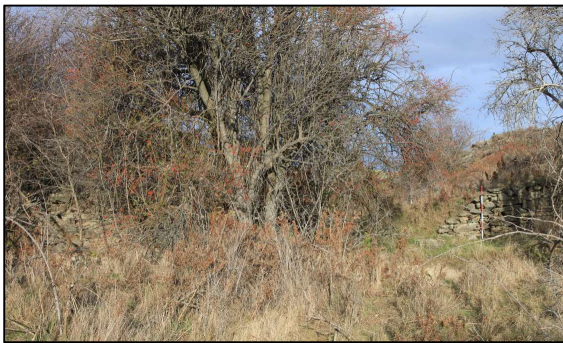
The dam wall (G41/717, GPS 123-124, Plate 10, Figure 5: Appendix 2) in Upper Waldron's Gully has collapsed in part requiring stabilisation to retain remaining fabric.

**Plate 10.** Dam wall (G41/717, GPS 123-124), Upper Waldron's Gully. View south-east (M Sole).

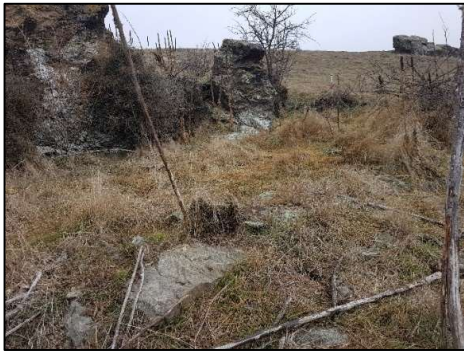
**Plate 13.** Chinese Hotel? site (G41/709, GPS 122), Waldron's Gully. View north-west.

The stacked stone foundation (foreground of Plate 13) and side wall of the Chinese Hotel? site (G41/709, GPS 122, Figure 5: Appendix 2) in Waldron's Gully requires stabilisation to reduce loss of fabric.

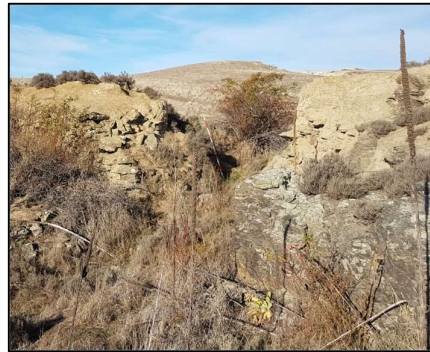
**Plate 14.** Lauderburn Water Race aqueduct (G41/701, GPS 102-103), Specimen Gully. View south-east.

There are two raised wall aqueducts along the alignment of the Lauderburn Water Race: the highly visible stacked stone and earthen walled aqueduct (G41/701, GPS 102-103, Plate 14) below Green's Reef in Specimen Gully, and a second possible aqueduct (GPS 100, Plate 15) constructed in stacked stone in the gully west of Blue Nose Gully. The stone/earthen wall in Specimen Gully has breached/collapsed in the centre of the wall requiring stabilisation. The stacked stone of the possible aqueduct (G41/701, GPS 100) are slowly falling from the wall and it is recommended the stonework be stabilised to prevent further collapse. A stonemason is to attend a site visit to assess requirements for the continued stability of the Lauderburn Water Race fabric.

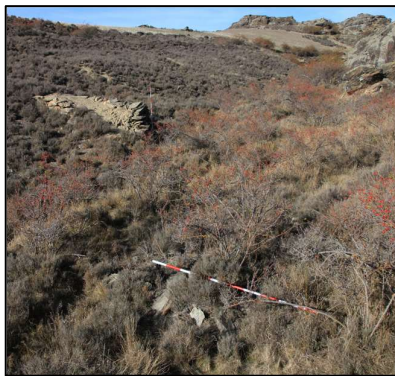
**Plate 15.** Possible aqueduct? (GPS 100 centre left) of Lauderburn Water Race and tent site (GPS 099) in foreground marked by ranging pole (G41/712). View M Sole.

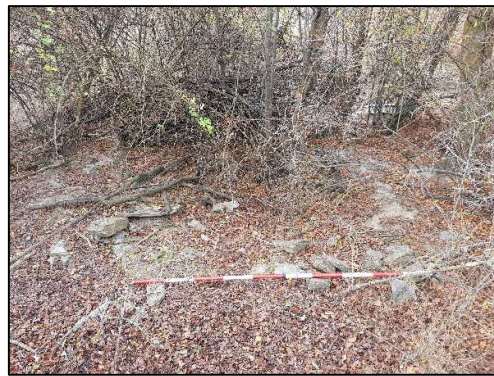
**Plate 16.** Tent/hut site (G41/715, GPS 380), Waldron's Gully. View east.

The stacked stone foundation of this tent/hut site (G41/715, GPS 380, Plate 16) has collapsed and is partially covered by tree leaves. A check of the site by a stonemason is recommended to see if there are any stone that could be effectively reinstated by applying mortar or if the best decision is to leave the site as is.

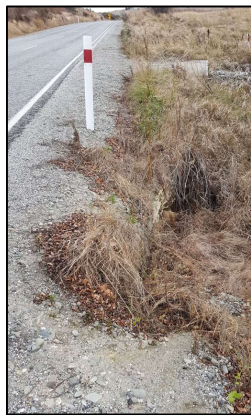
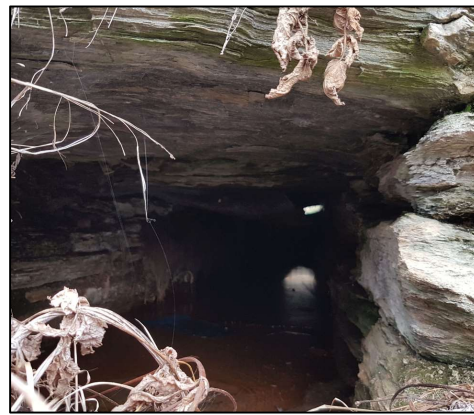
The north (lower) side of the stacked schist culvert (G41/575, GPS 376, Figure 3: Appendix 2) beneath Ophir Bridge Road is bowing (Plate 17) and the stone stacking is becoming loose in the eastern internal channel walling (Plate 18). A stonemason or engineer is to inspect the stacked stone culvert and determine action if required. If modification to stabilise the culvert is the chosen option communication is recommended with Heritage NZ as a *Pouhere Taonga* Authority may be required to carry out any planned work to this 19<sup>th</sup> Century stacked stone culvert (G41/575).

**Plate 17.** Stacked schist culvert (G41/575, GPS 375), north side Ophir Bridge Road. View west.

**Plate 18.** Stacked schist culvert (G41/575, GPS 375), Ophir Bridge Road. View south.

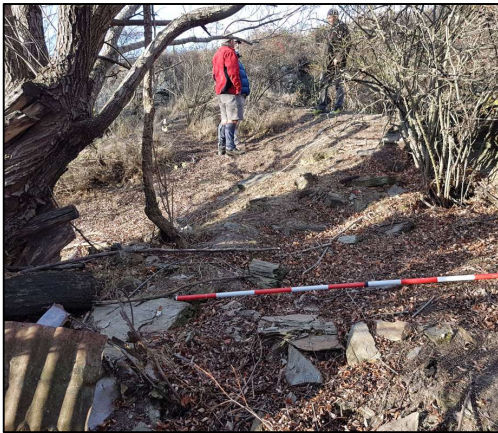
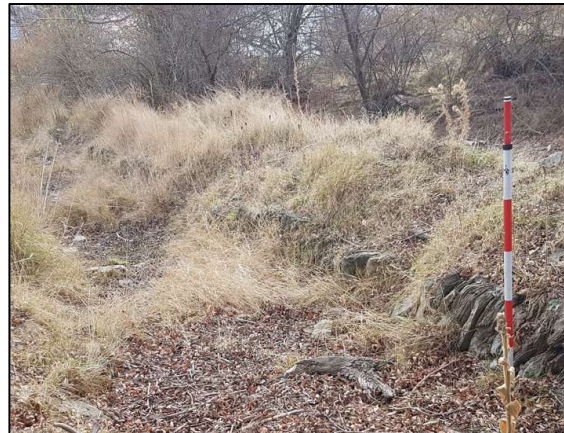
Briar is growing directly against the stacked stone wall of a small dam (G41/714, GPS 378, Figure 4) across lower Waldron's Gully (to right in Plate 19) and a large tree is growing from the water outlet of the dam (to left) at the head of the stone lined water race. The upright schist lined water race requires management of the grass in order to view the striking feature leading to Swindon St (Plate 20).

**Plate 19.** View east to small dam wall (G41/714, GPS 378), lower Waldron's Gully, and Matthew Sole.

**Plate 20.** Upright stone (schist) lined water race (G41/714, GPS 378). View north-west to Swindon St. Small dam behind photo taker, lower Waldron's Gully.
